Concord 1888 Gasholder House Structural Evaluation and Environmental Impact

NH Hazardous Waste & Contaminated Sites Webinar Series

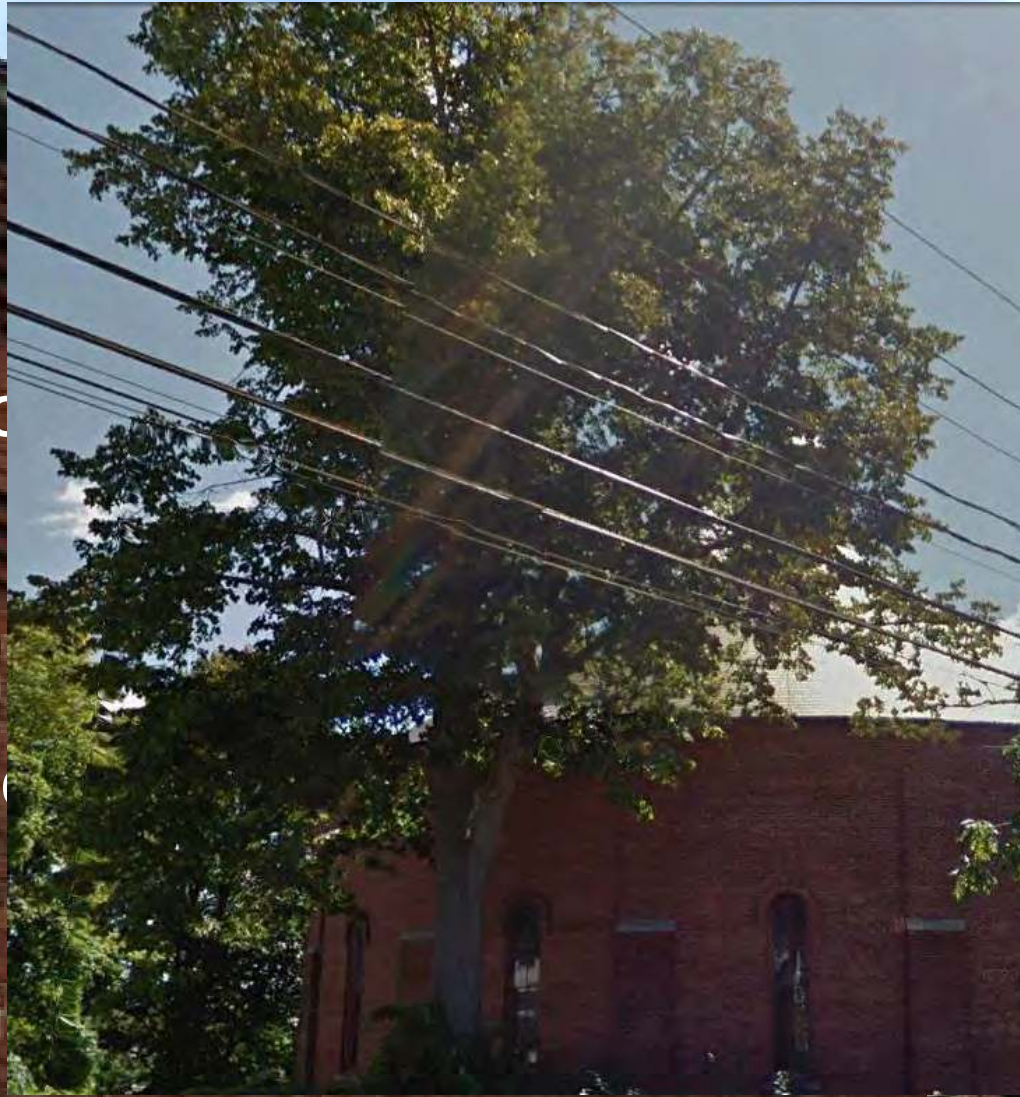
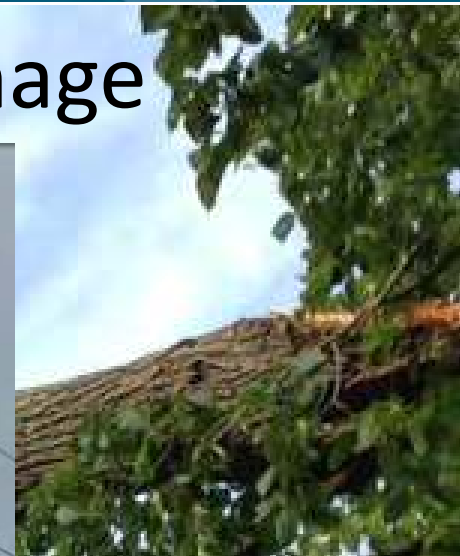
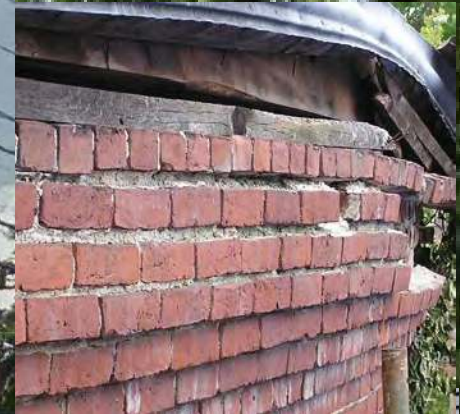
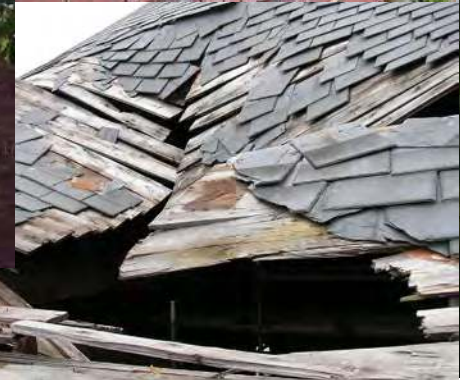
June 17, 2013, Storm/Tree Damage

Penetration

Damaged

Damage to

Brick ring

displaced
