Case Study:

# Gasoline Tanker Roll-Over

## Initial Response Actions and Restoration

NH Route 101, Epping, NH

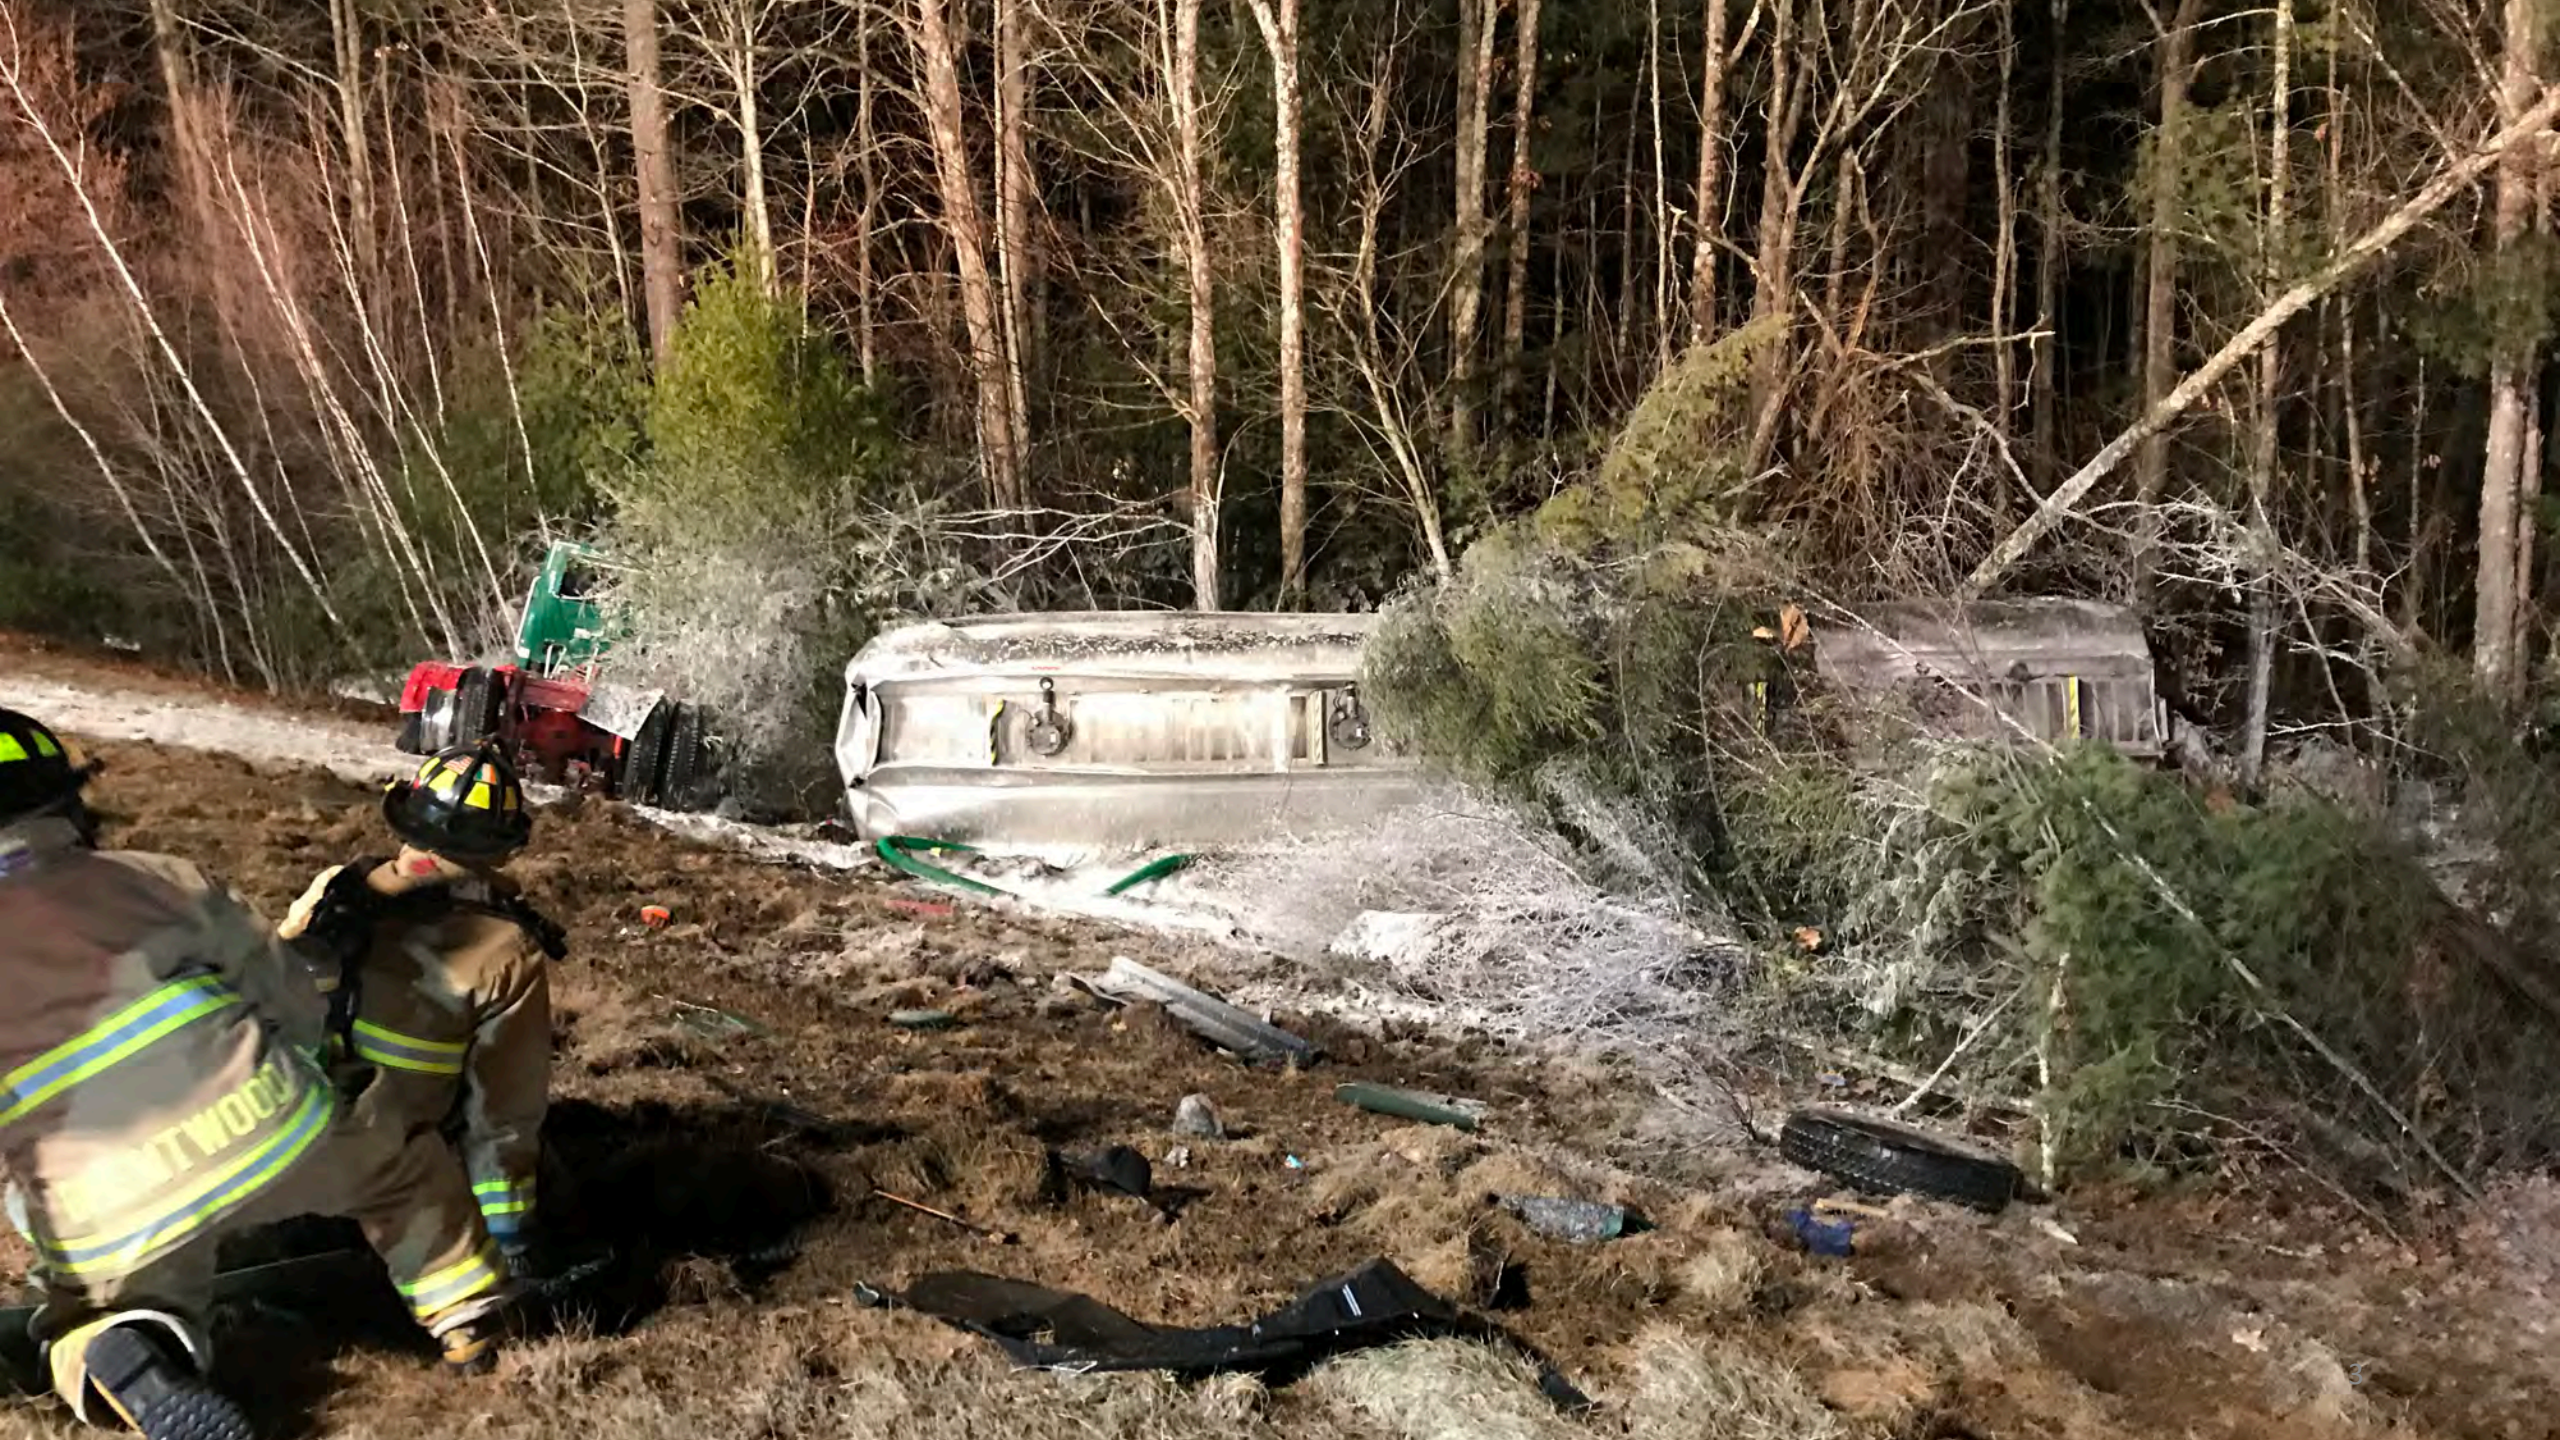
- “Gasoline gushing out like an open fire hydrant”
- 11,000-gallon capacity
- Multiple Fire Departments on scene
- Emergency Response Contractor dispatched
- Spill into wet wooded area

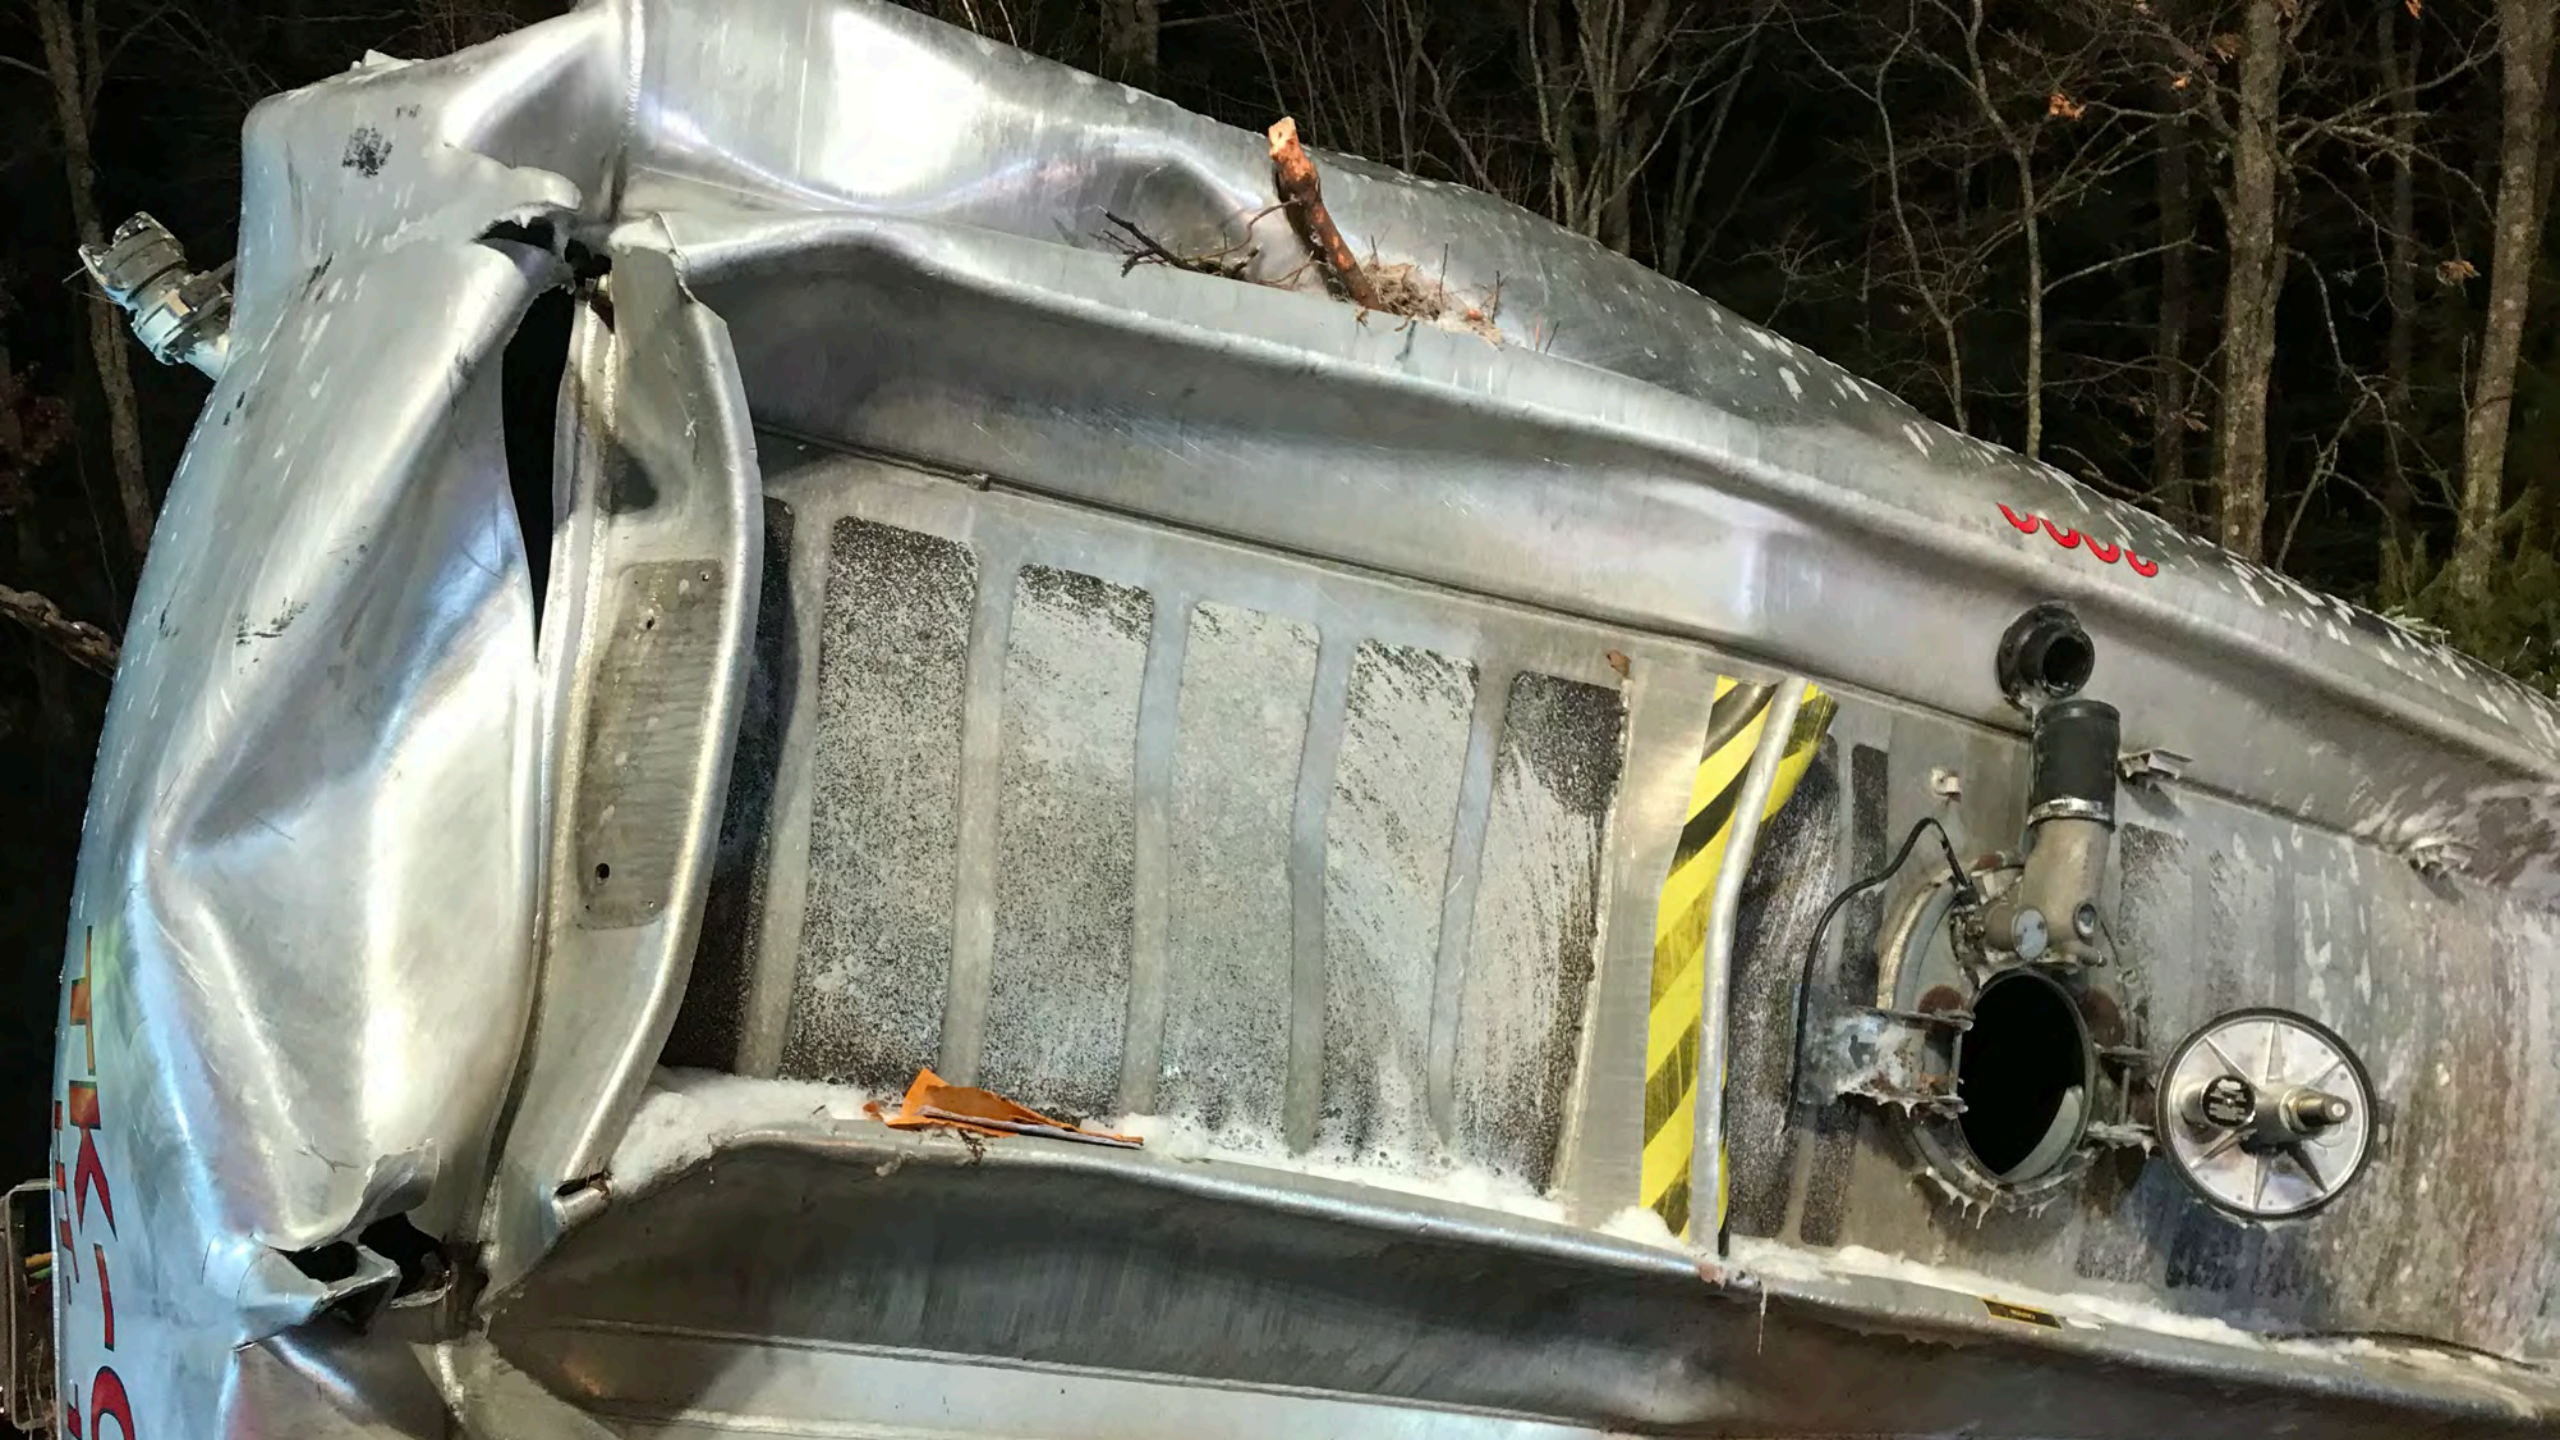
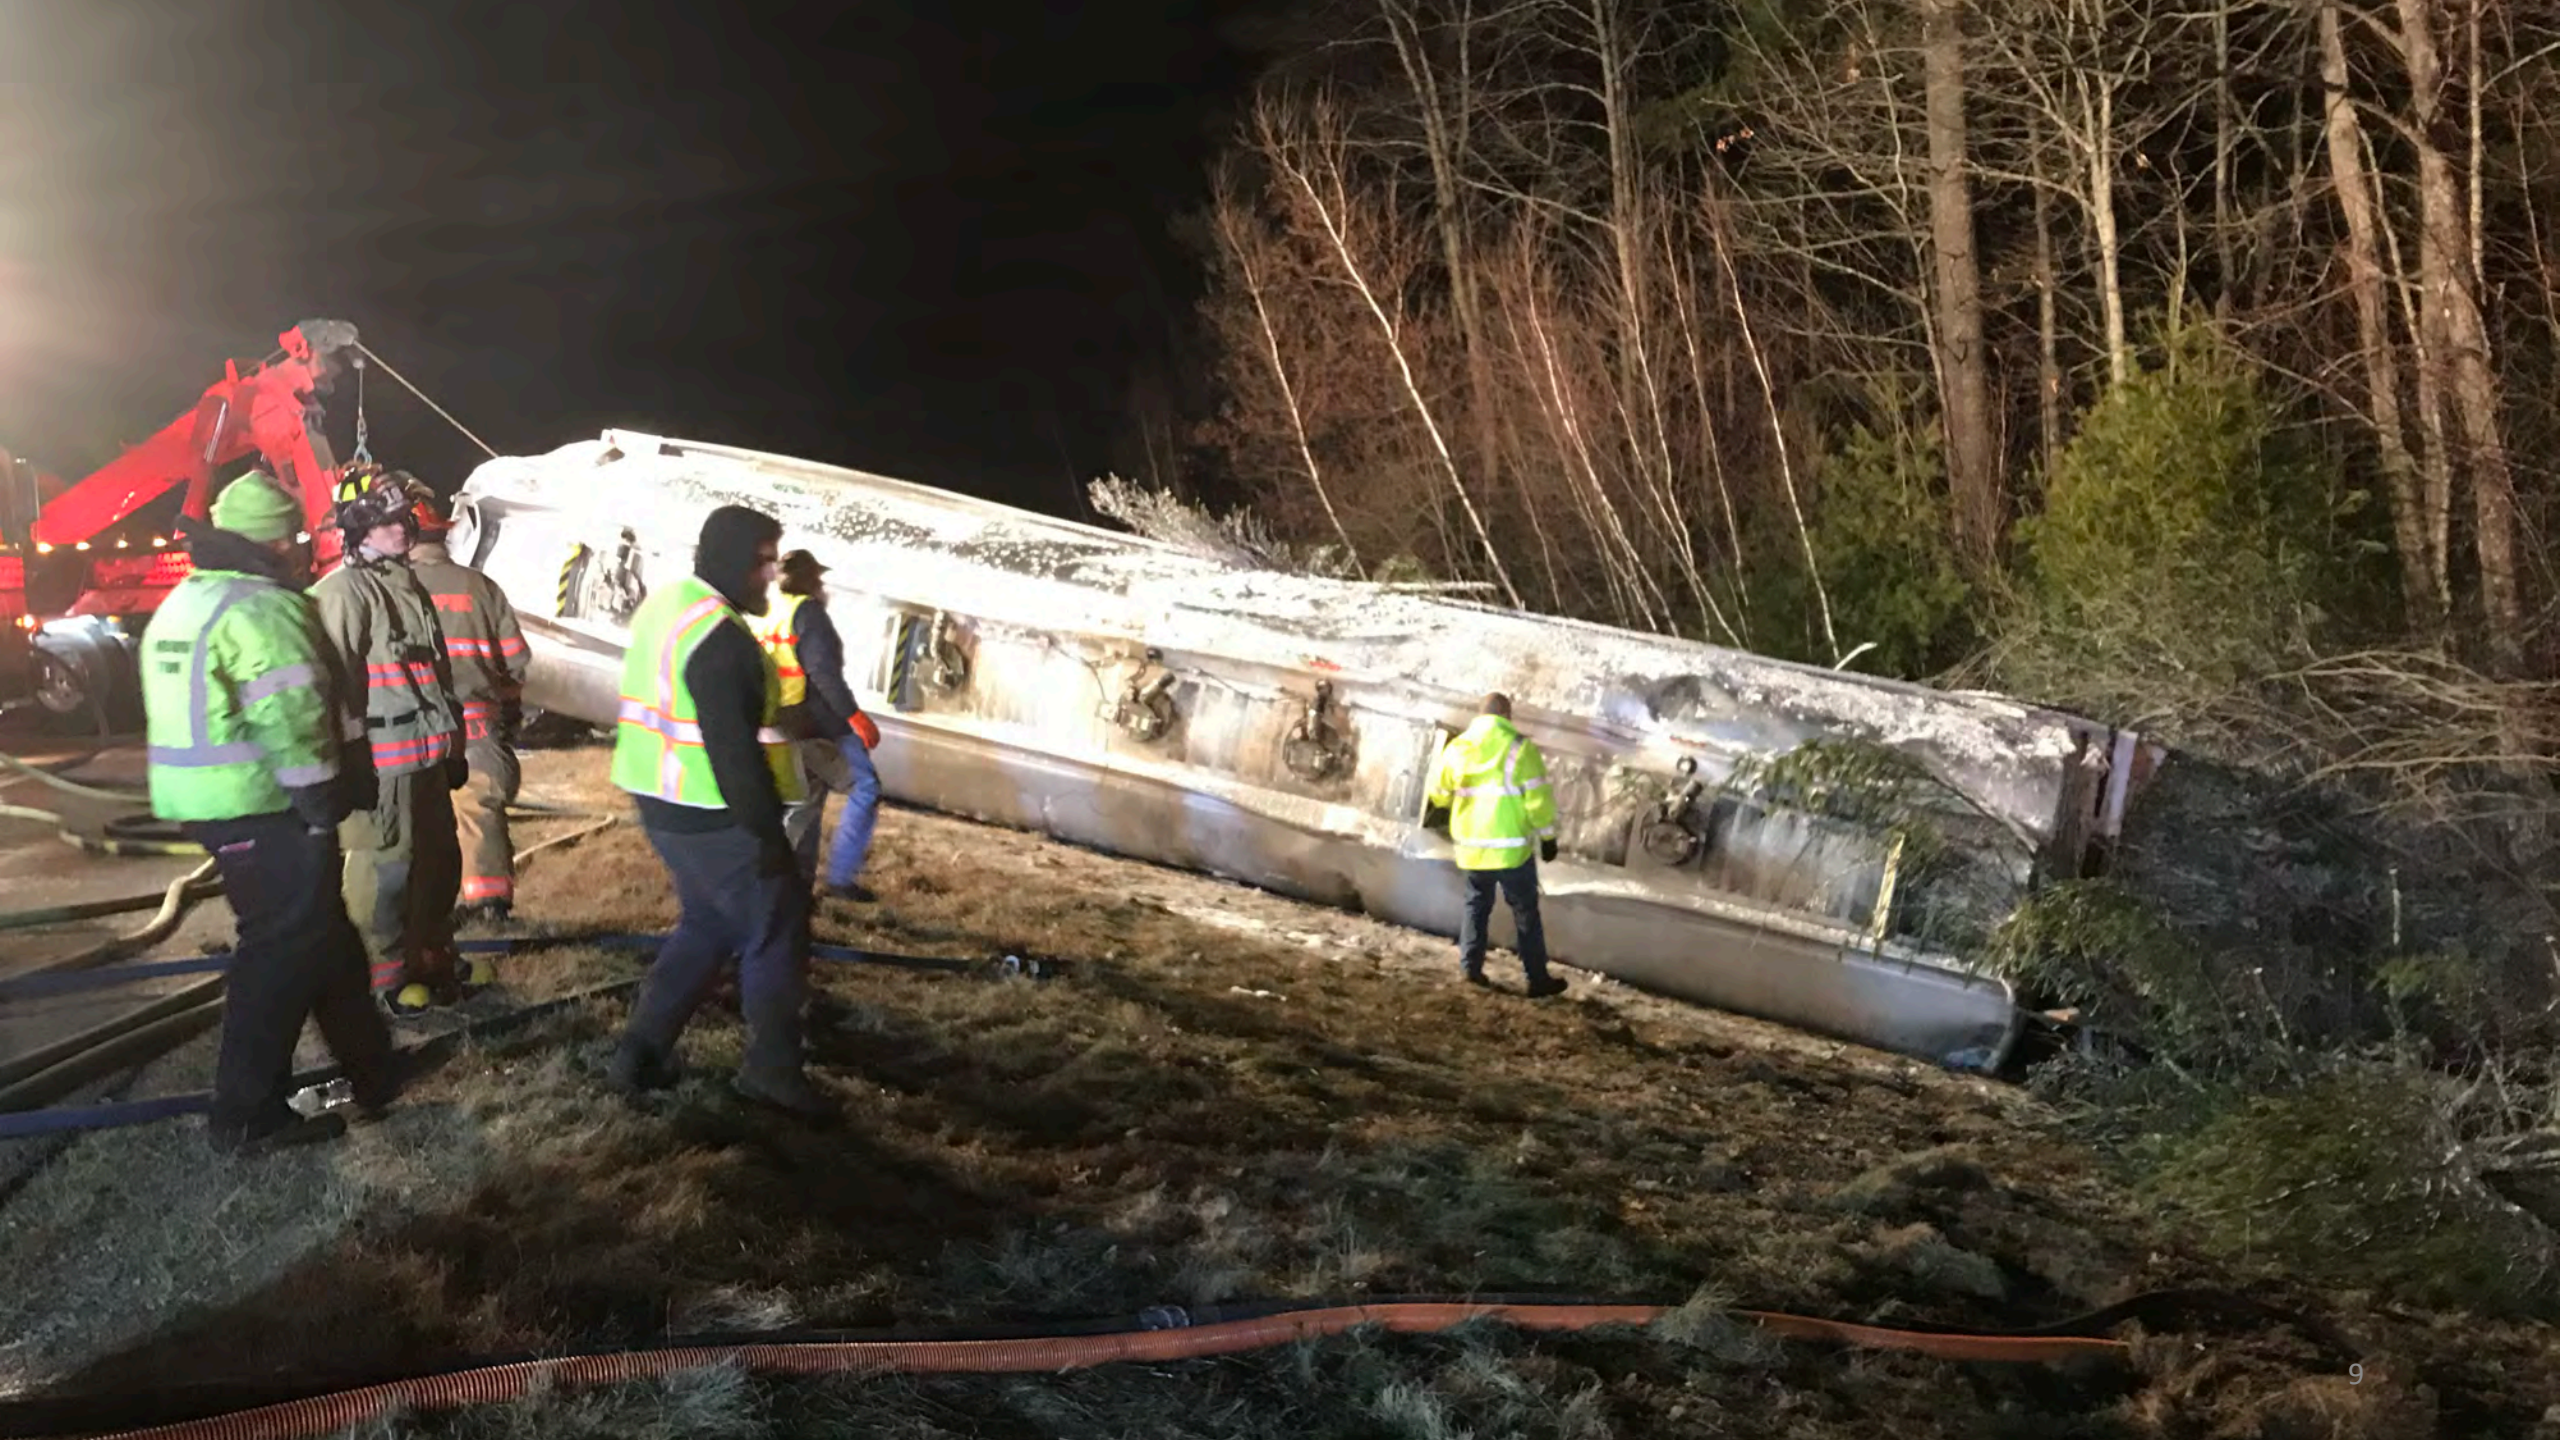
# Tanker Recovery and Assessment

- Significant damage to front headwall of tanker
- Piping and valve gallery intact
- Did not tap into tanker due to flammability – opened hatches front to back
- Interior baffles compromised
- Recovered ~4,500 gallons of virgin gasoline from rear compartment
  - Estimated ~6,500 gallons released to the ground

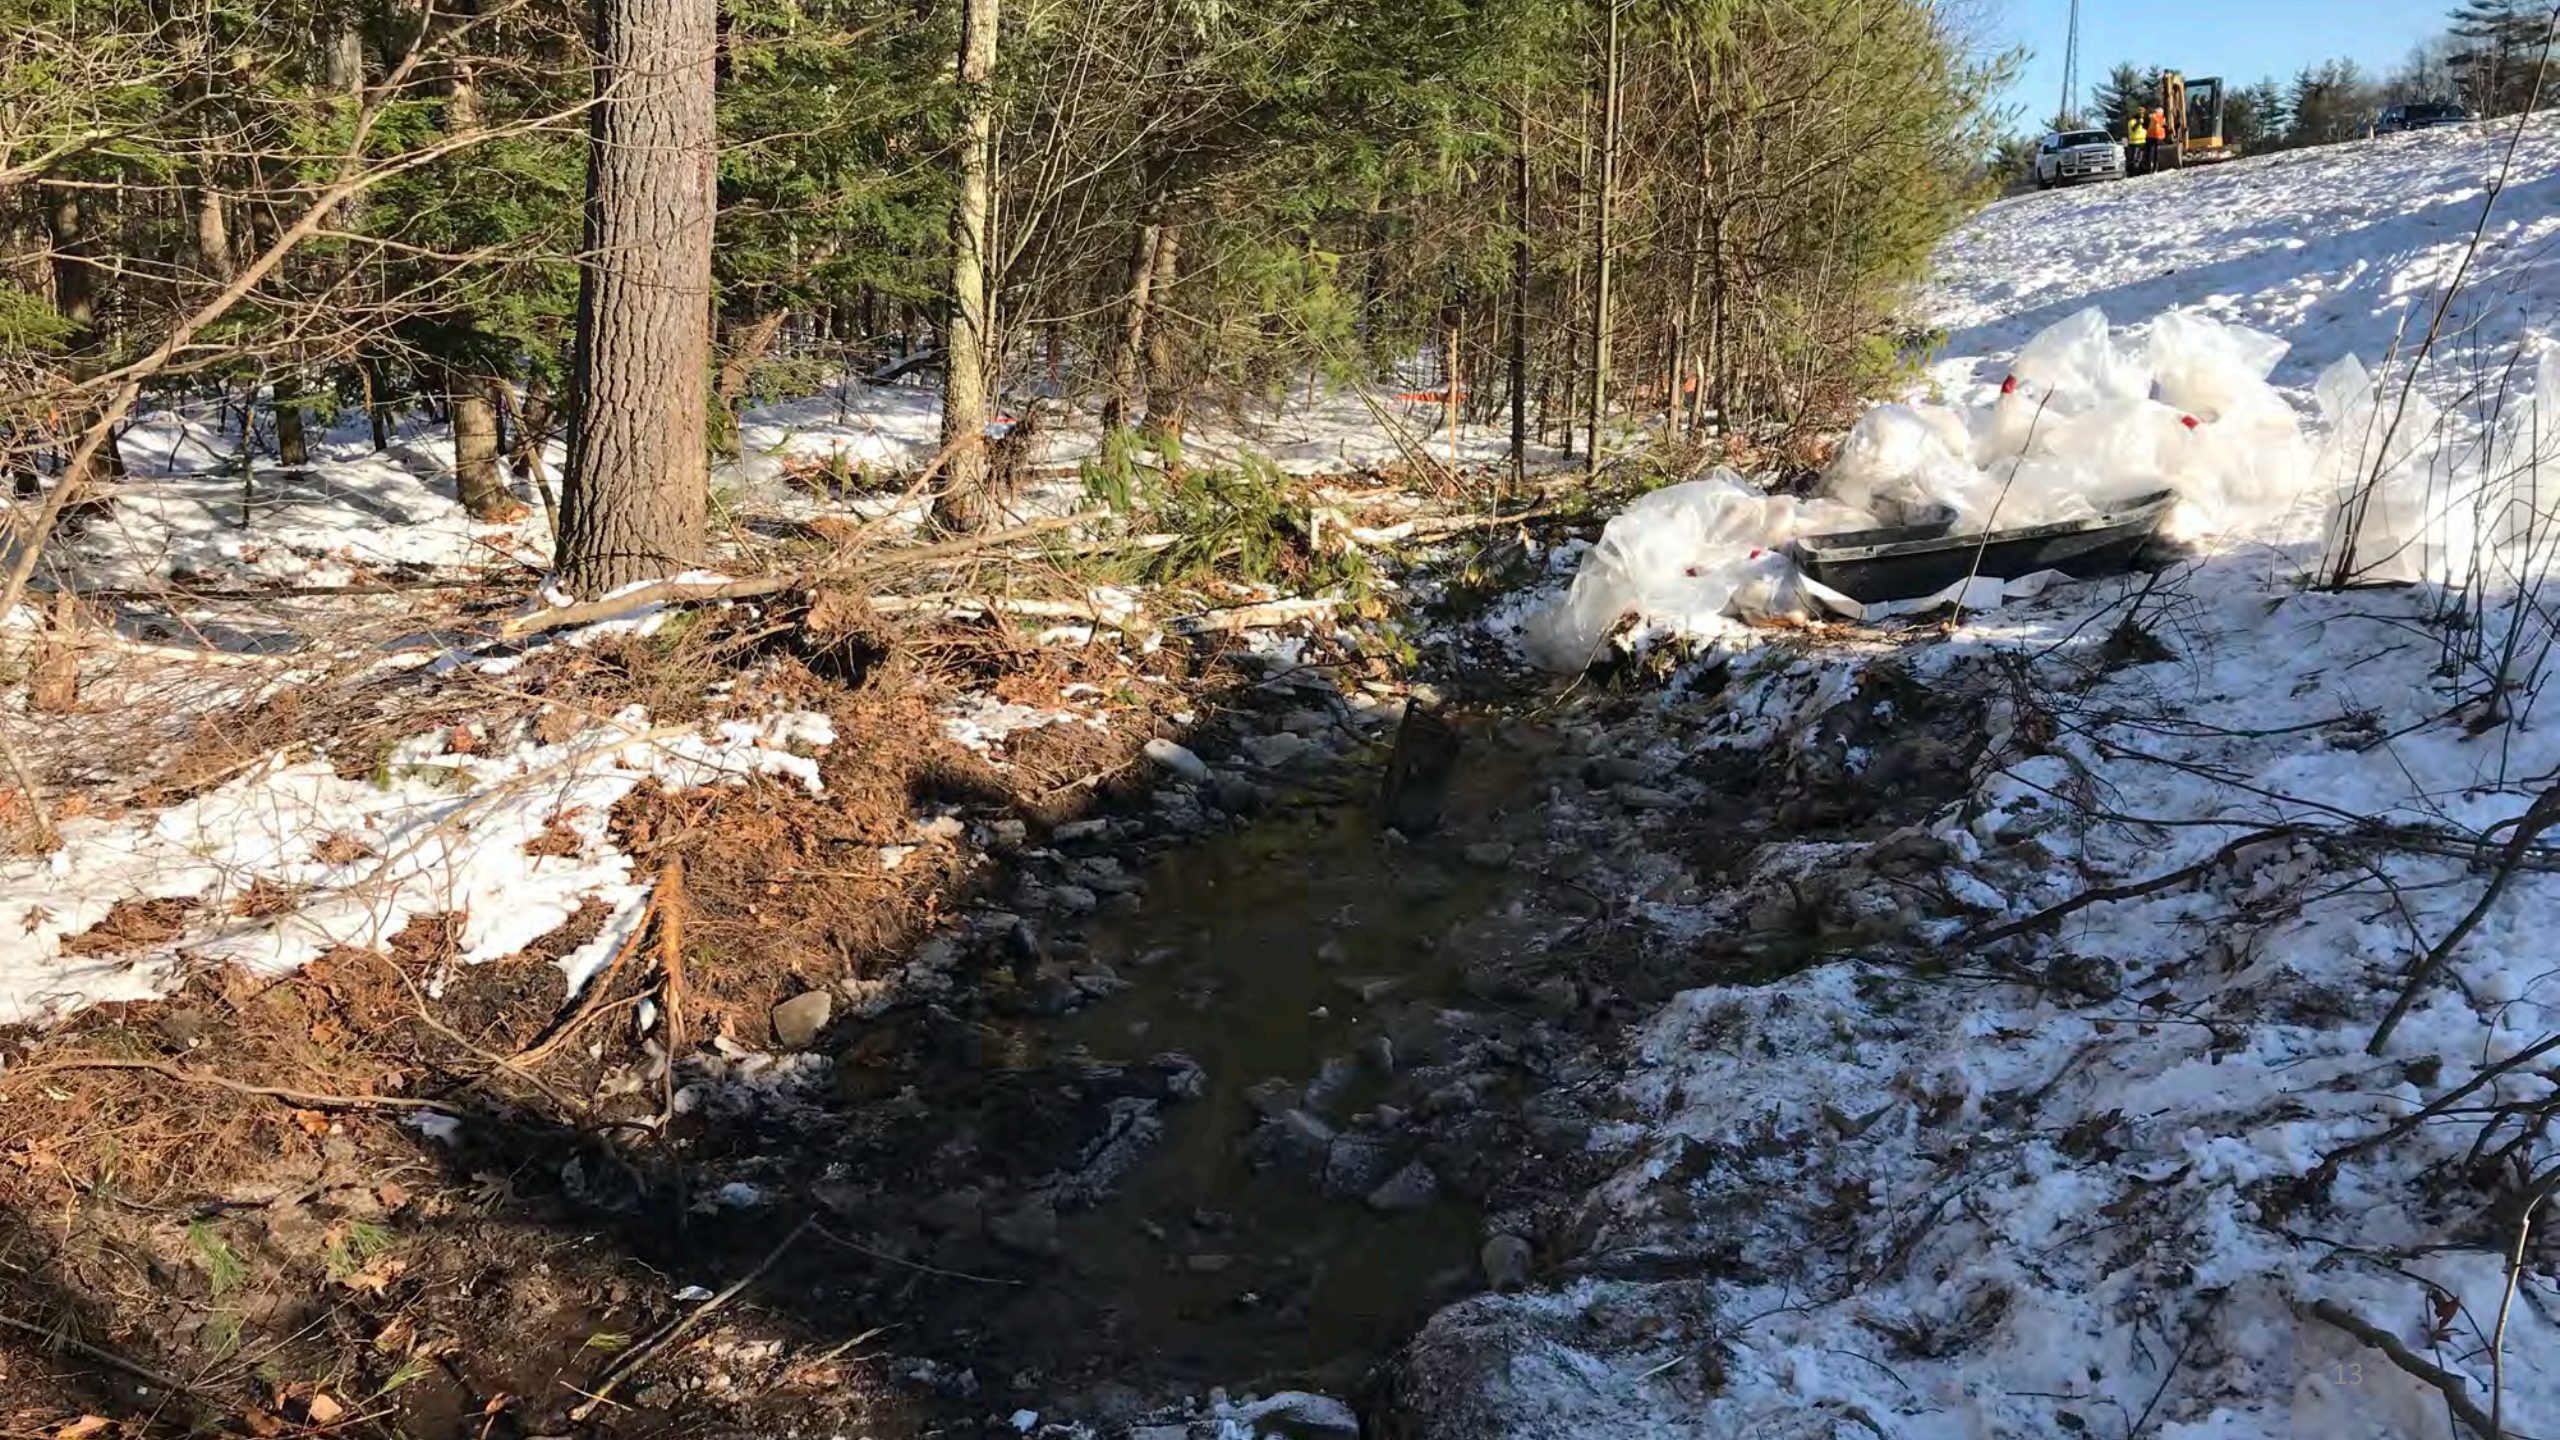
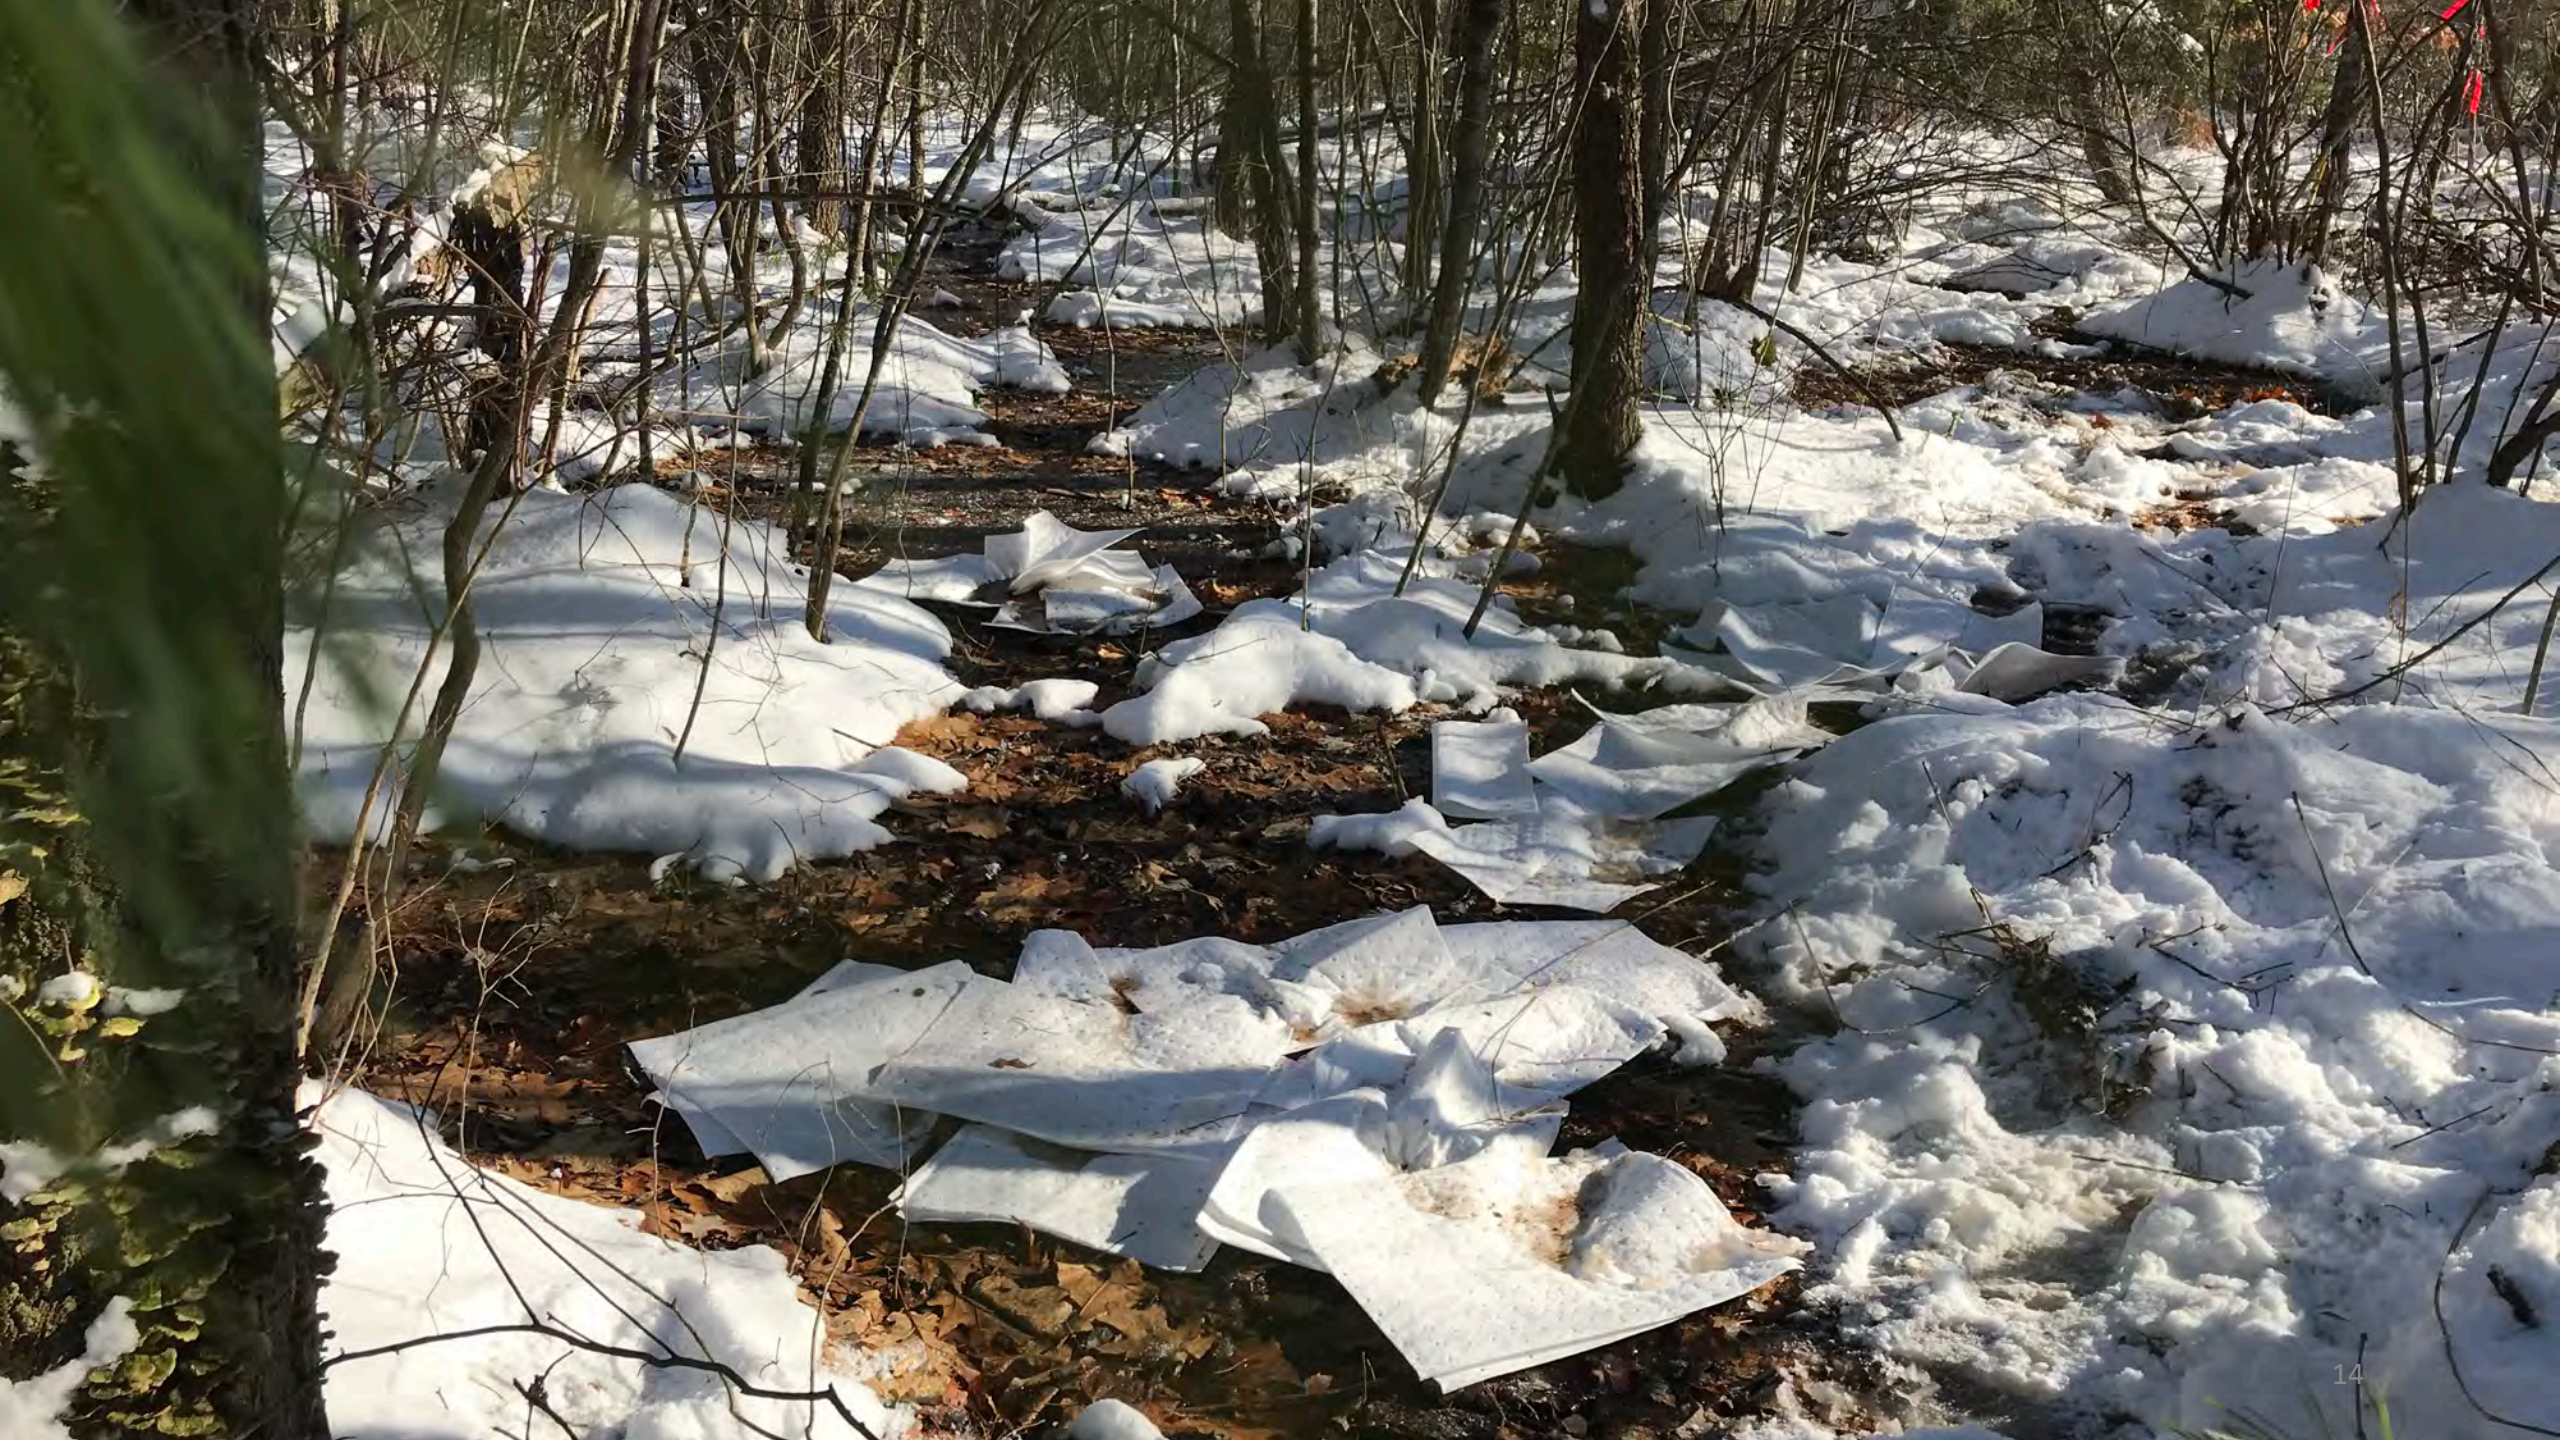
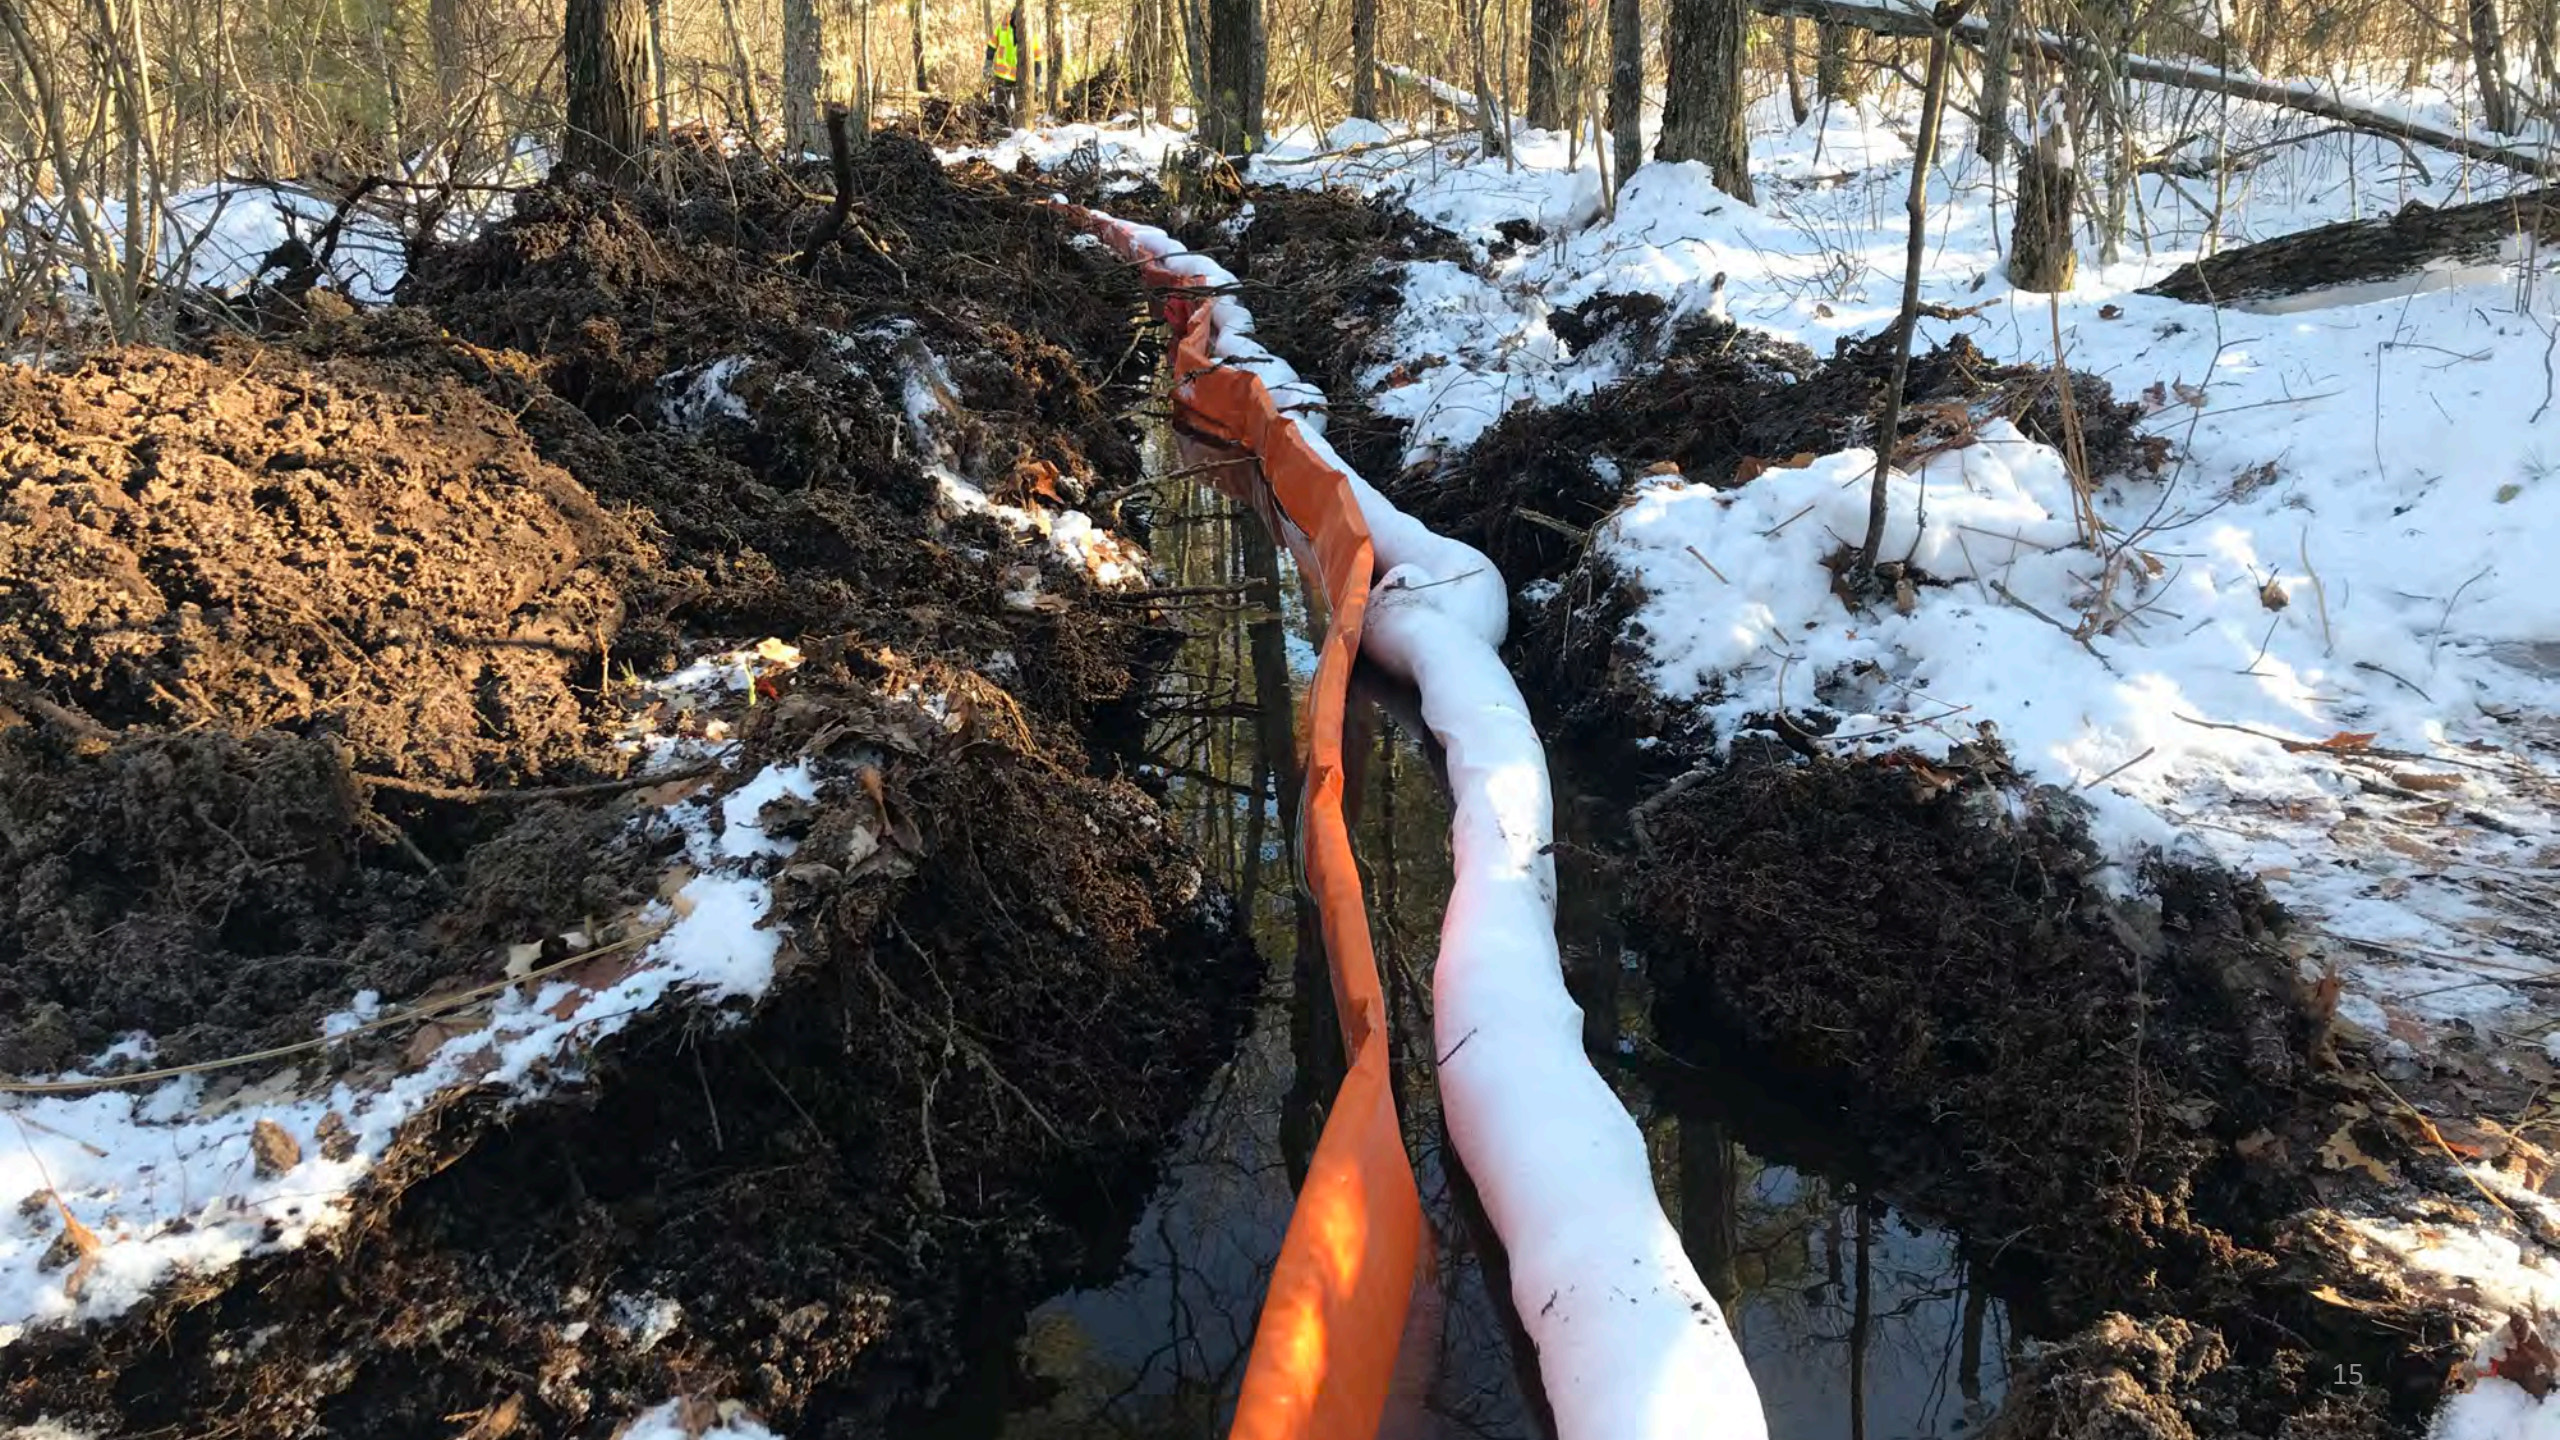
# Ongoing Stabilization and Recovery Work

- SAFETY – Side of Roadway, Gasoline vapors
- Contractor continued pumping pooled gasoline from source area and surrounding area
- Determined the extent of impacts and migration path of gasoline
- Absorbent pads and boom deployed in exposed pools of gasoline
- Large interceptor trench excavated east of the release area, down-gradient of impacts
