Application of Water Supply Exploration Techniques to Contaminant Transport Investigations in Fractured Bedrock, a Toolbox Discussion

2024 New Hampshire Environmental
Regulatory Conference

Ottati & Goss Superfund Site-Kingston, New Hampshire

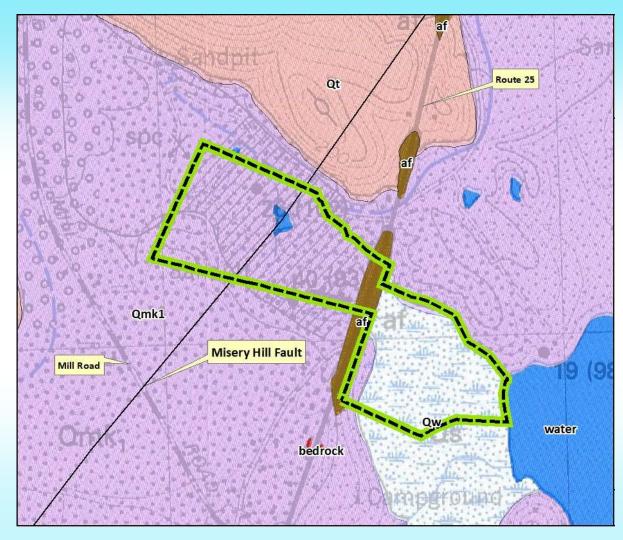
Surficial Geology at Ottati & Goss Project Site

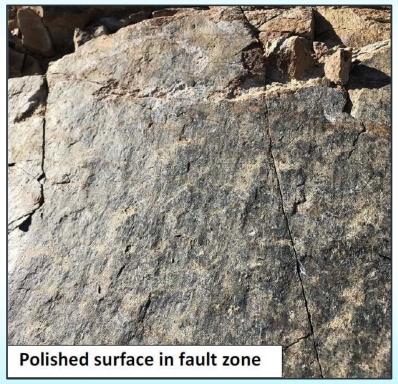
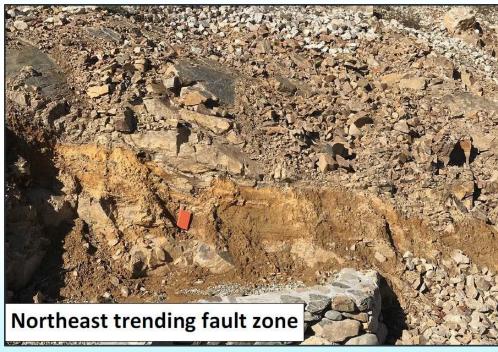
Rock Types Identified within the Misery Hill Fault Zone

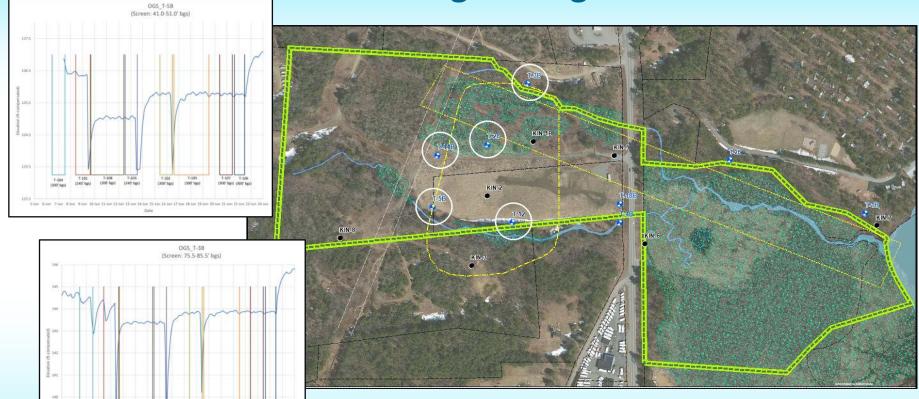
Water Levels in Selected Monitoring Wells Observed During Drilling
