Case Study:

# Gasoline Tanker Roll-Over

## Initial Response Actions and Restoration

NH Route 101, Epping, NH

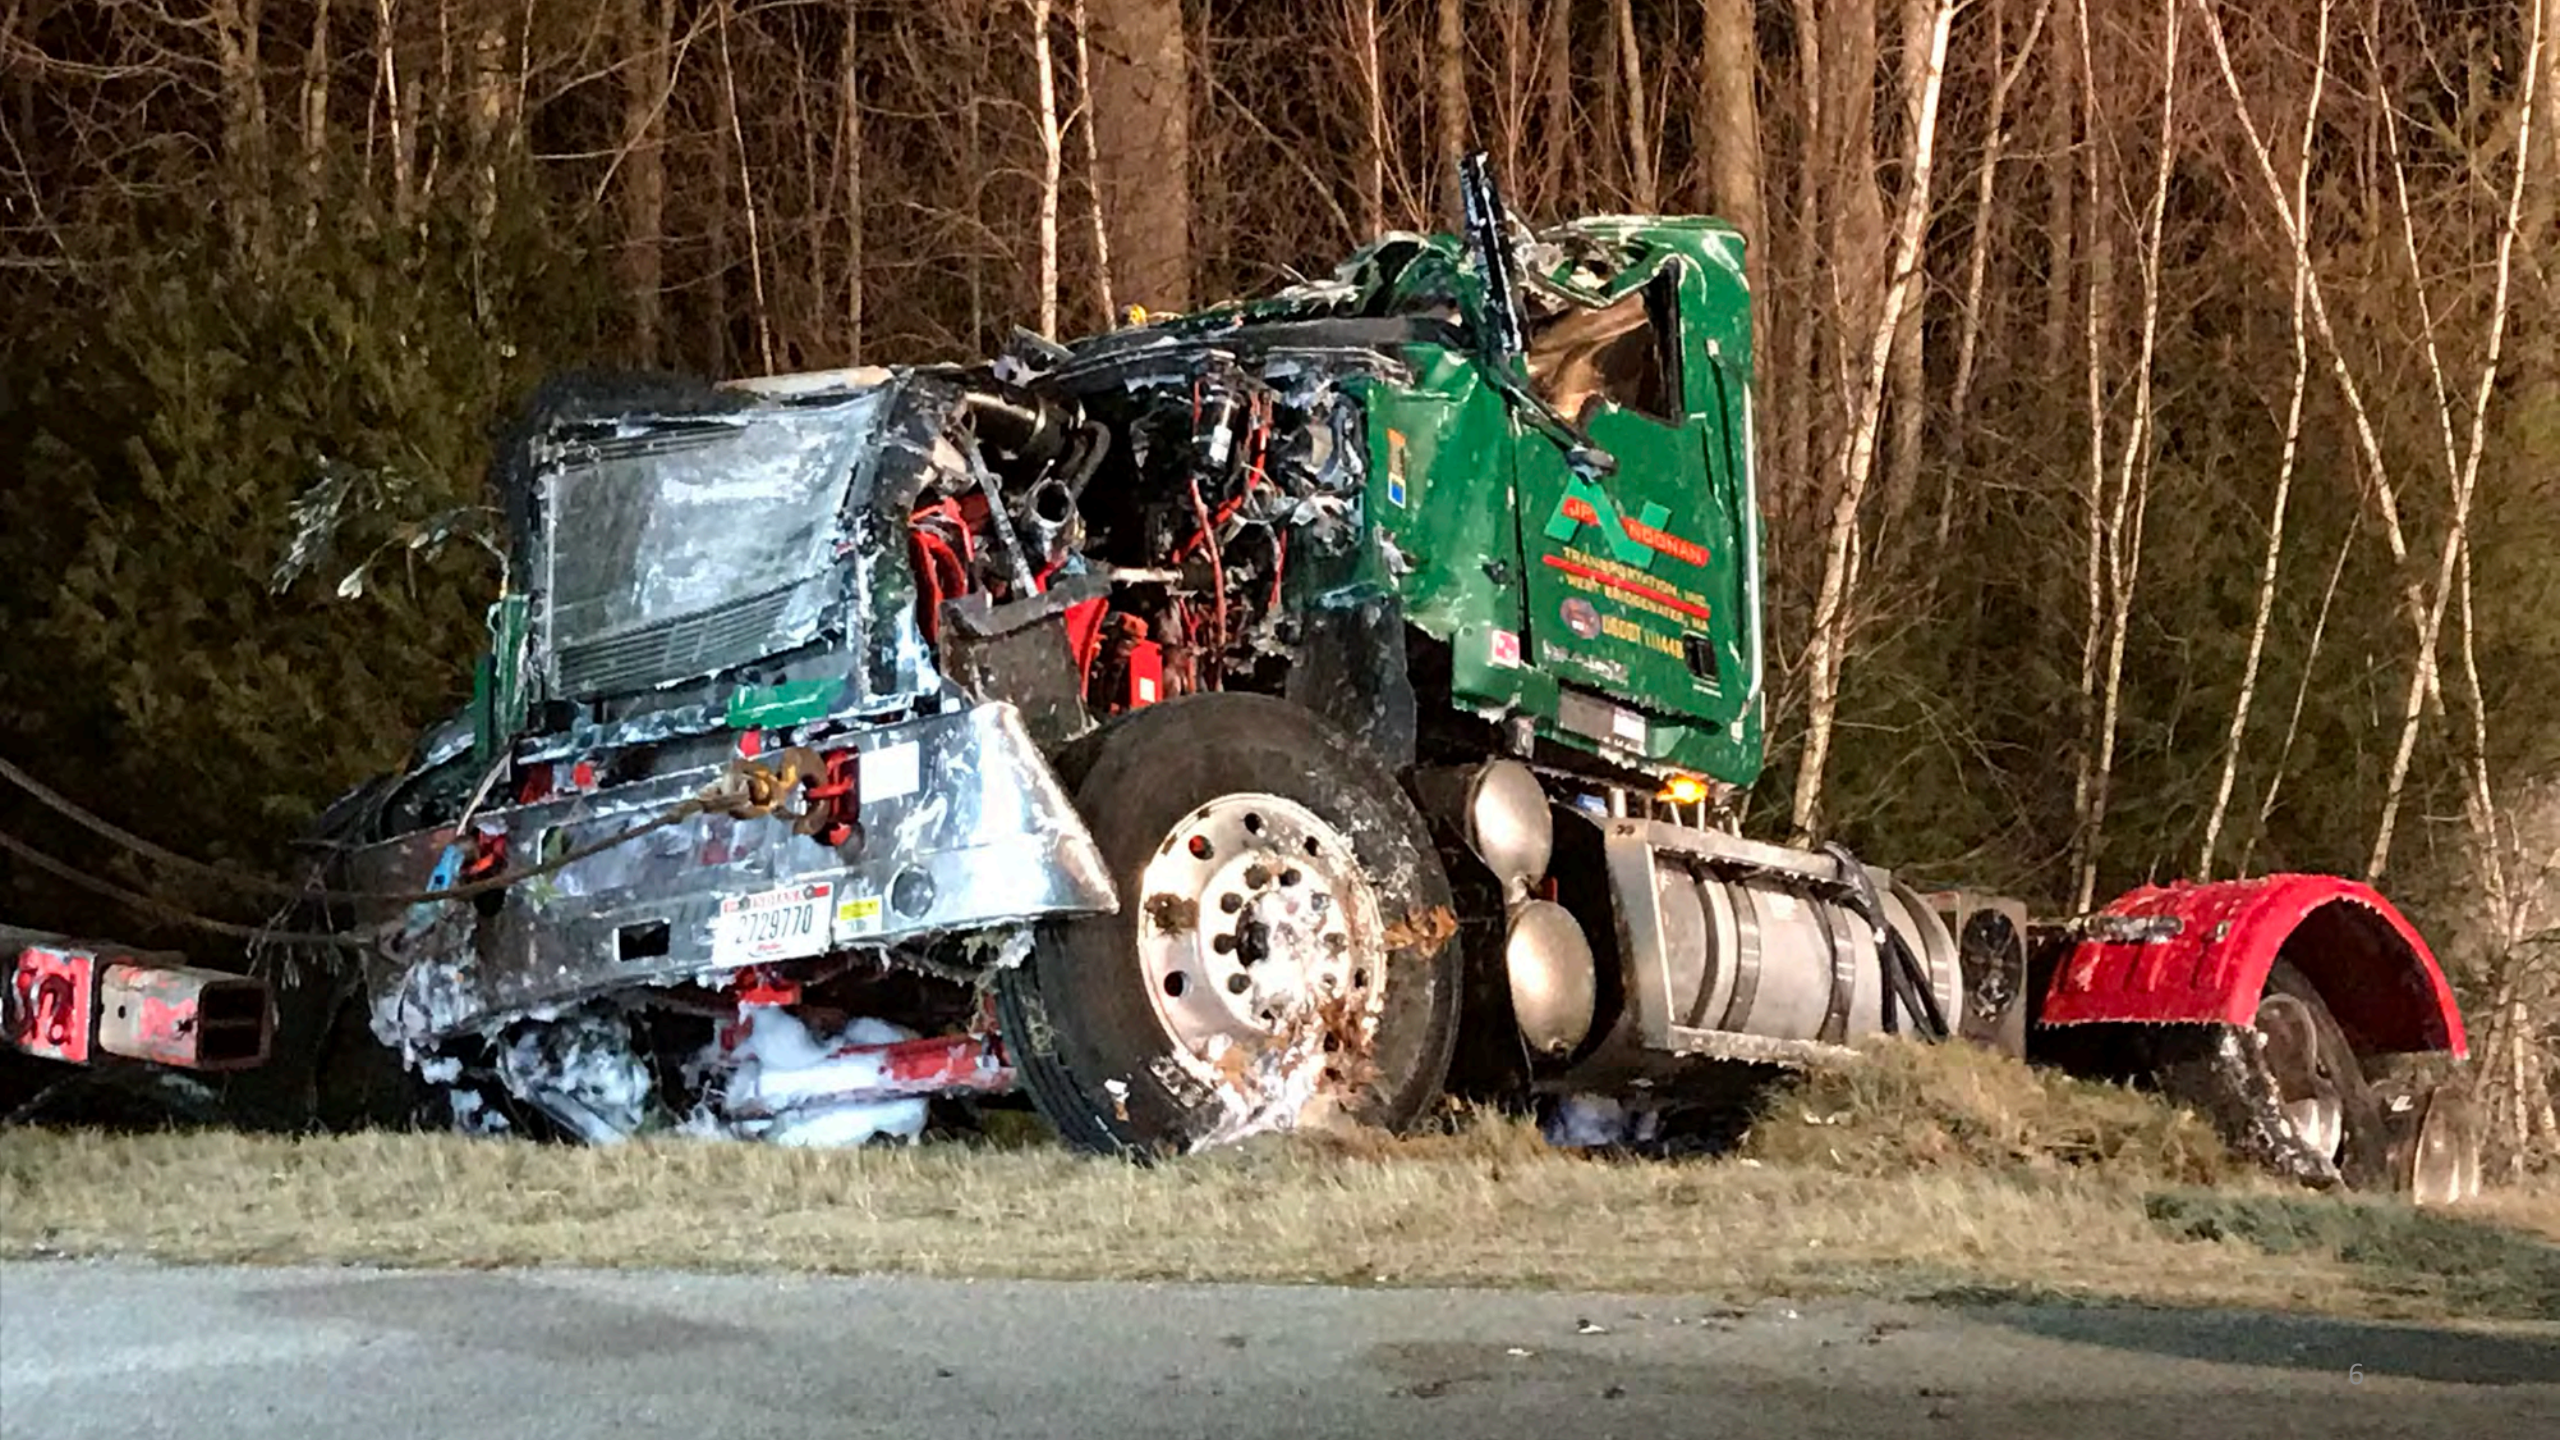
- Highly flammable liquid with low S.G. into wetland area
- Night operations - low visibility
- Below freezing temperatures
- Snowstorm forecast to begin in ~10 hours
- >100 personnel on scene

- Scene safety – PREVENT FIRE
- Remove truck from crash scene
- Assess tanker and pump out remaining gasoline
- Remove tanker from crash scene
- Assess impacts and potential migration
- Recover pooled gasoline
- Stabilize scene and clear road before snow storm
